Smoke and Dye Testing Summary

High Level Sewershed

Test ID	Test Type	Date Inspected	Company / Super.	Blower MH	Ground Condition	Notification Made?	Total Length
S1028-224	Smoke	8/10/2009	ADS/TM	S19KK_012MH	Dry	Yes	348.84

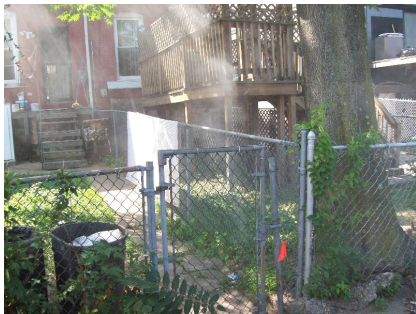
Picture \S1028-224-OB01-P01.jpg

Source Cleanout

Location Yard - back

Comments Smoke from cleanout in back yard. 2111 Smallwood St.

Comments Back of house, 2111 Smallwood St.
